# Manhole Inspection Summary

Manhole # S57EE\_022MH

Insp Date: **3/19/08 1:00 PM**

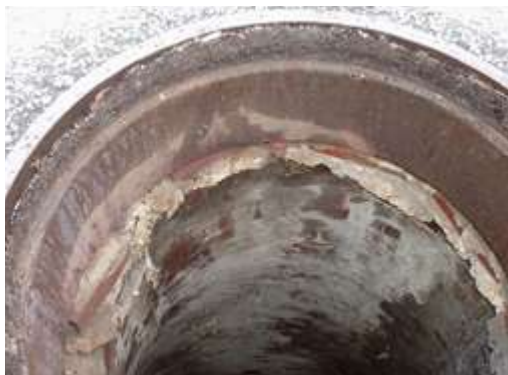
Defect 2

☒ **Loose Brick**

☒ **Deteriorated**

Loose Bricks

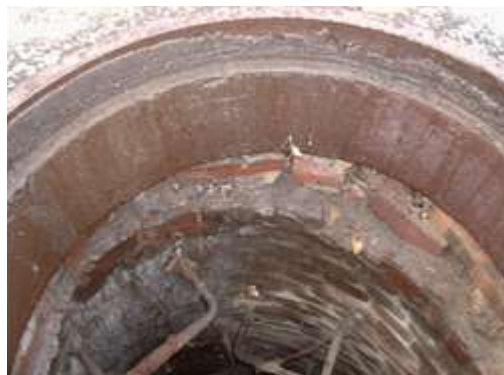
Defect 1

Offset: **3** (in.)

Adjustment Offset

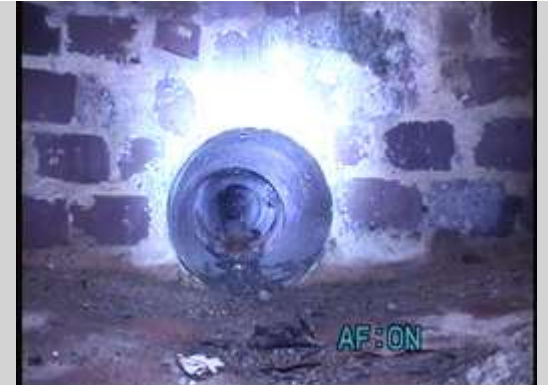
12 O'Clock Outflow

8 in. Circular Gravity Sewer  
Pipe Out @ 12 O'Clock

Infiltration: **None** Pipe Seal Cond: **Sound**
